## Asset Management Case Study - FMJL Current Transformer (CT) Failures

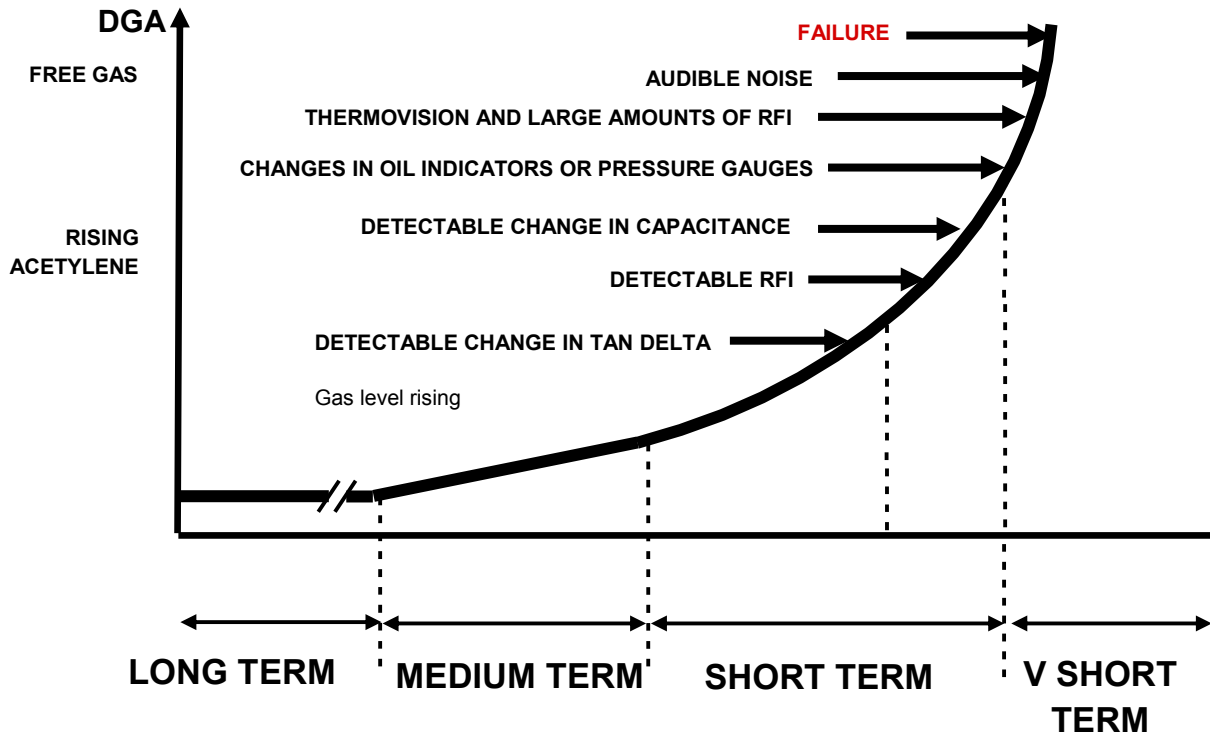
### **Progression Mechanism for a Dielectric Failure of the Insulation in an Oil Impregnated Instrument Transformer**

Major insulation failure of toroid or stem insulation can be due to:-

- Materials / Manufacturing Defect (normally 'burn in' issue)
- Degradation by partial discharge
- Degradation due to thermal or moisture or poor quality of oil
- High Temperature Operation
- HV internal bonding lead connection failure
- Loss of Insulation oil
- Breather blockage
- Open Circuit CT / CT Test Tap
- CT on open circuit develops an infinite voltage leading to rapid insulation breakdown and disruptive failure

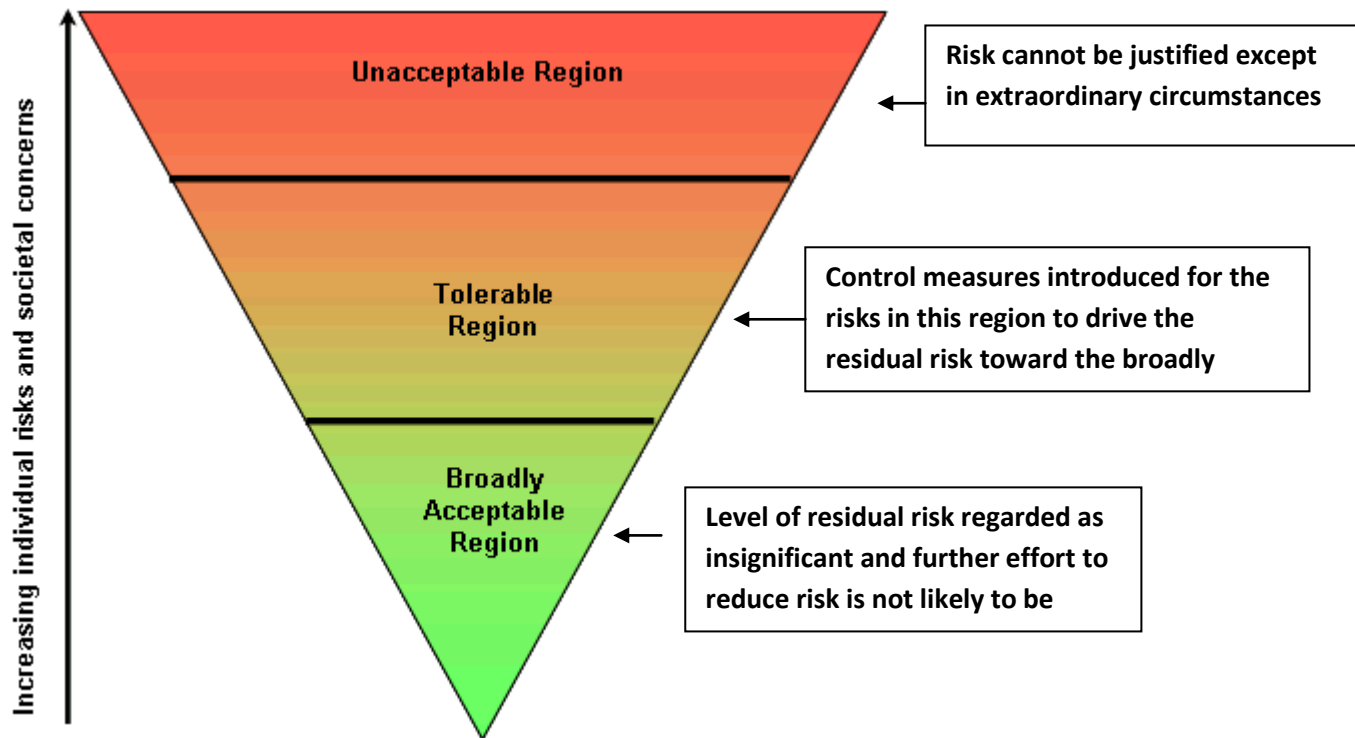
A Quantified Risk Assessment was carried out based on ALARP principles using historic failures, number of units, length in service, equipment condition data, ballistic data, diagnostic data, exposure, and vulnerability. The findings were that there was an unacceptable risk under normal site operating conditions putting public and staff at risk. In 2009 this impacted 142 sites affecting 40% of the transmission network.

Risk mitigation considerations (following the ERICPD principles – Eliminate, Reduce, Isolate, Control, PPE, Discipline):

- Switch Out (remove the hazard)
- Risk Management hazard zones (75m)
- Physical Barriers (ballistic screening)
- PD Monitoring and alarm

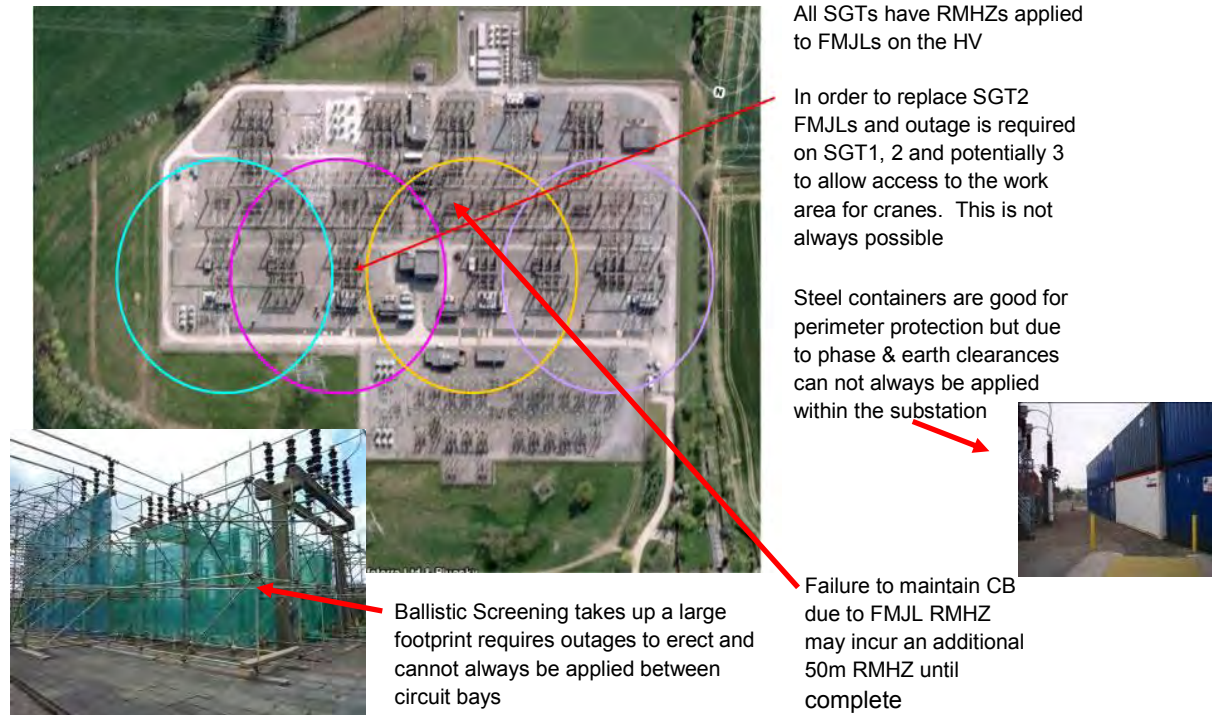
## Overlapping RMHZ – Restricting Access, Impact of Overdue Maintenance and Mitigation Measures

In 2009, 94 Site Specific Risk Assessments were undertaken in one week where the hazard zone extended onto public land.
