**2017 SHE REVIEW
OF PAST INCIDENTS
ASSET MANAGEMENT**

POWERING IMPROVEMENT 2015 – 2020

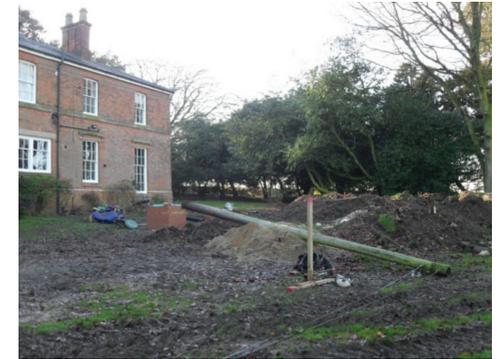
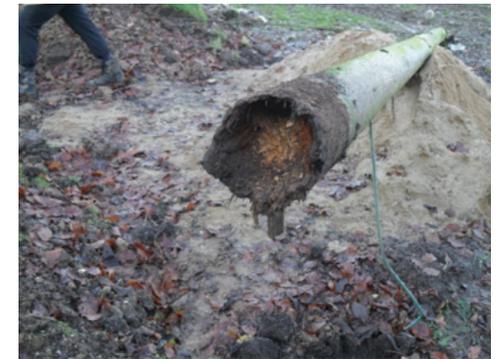
The terminal pole had been identified as having decay at the pole top but no "D" label was fitted; the pole was over 50 years old. On the day in question the linesman tested the pole using a hammer test and this did not indicate the pole was unsafe to climb. The linesman climbed the pole to disconnect a service span in preparation for recovery of the pole. As he did so the pole failed at a point below ground level and fell to ground with the linesman attached. The linesman suffered two fractured ribs, a chipped vertebra and a minor lower leg injury.

The inquiry concluded that the current pole integrity testing techniques may not be sufficient to identify below ground decay in all cases, and further controls were therefore necessary to reduce the

Key recommendations following this incident were:

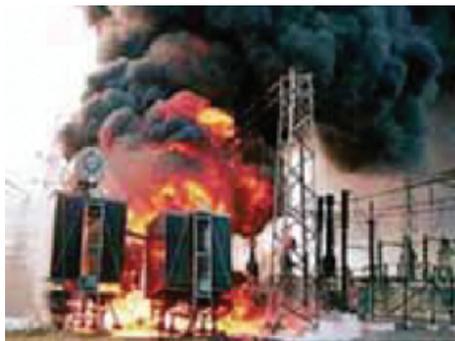
TAP CHANGER FATALITY (2008)

A fatal incident occurred when an engineer tried to manually operate a high voltage tap changer and the unit exploded, killing the engineer. The direct cause of the incident was the failure of the mechanism in the tap changer leading to an electrical fault, which caused the oil in the unit to ignite and explode.

- > A failure to carry out a modification to the tap changer which had been recommended some years before;
- > The failure to understand the significance of repeated tap changer alarms and malfunctions.

The investigation concluded that: “the explosion occurred because sector contacts were unable to full engage following a tap changing operation. The excessive current loading on the reduced contact area caused a temperature rise which eventually led to localised arcing

and the rapid decomposition of the oil and spreading dielectric failure. This failure to engage was caused by the seizure of the moving arm of the phase changeover switch, which in turn caused slippage or breakage of the epoxy resin drive shafts at two locations.”

- > Alarms and defects on plant should be dealt with by staff who are trained and experienced in the maintenance of that type of plant;
- > A robust asset management system is needed to ensure that recommended modifications are recorded, scheduled and carried out, to ensure an accurate equipment and site history is maintained;

- > Manual live operation of tap changers should be reviewed and risk assessed, with appropriate controls applied;
- > Where evidence exists that the internal mechanisms of either the diverter or selector are damaged, then the unit should not be operated live;

- > Ensure that staff dealing with alarms and defects on equipment have the knowledge, skills and competency to deal with that equipment.

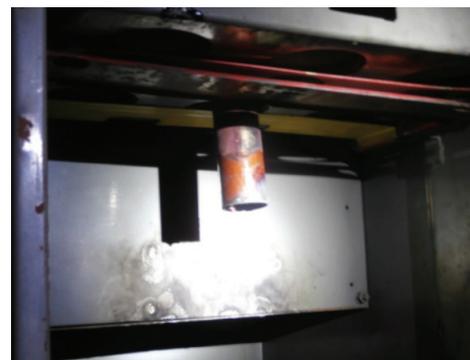
SWITCHGEAR FAILURES (2016)

During the process of restoring an 11kV circuit at a main substation, a Senior Authorised Person (SAP) came into contact with a live high voltage conductor and subsequently suffered serious injuries. This resulted in the employee suffering serious 25% electrical burns to his body and being off work for a considerable time.

- > Understand the switchgear you are operating on - If you are unfamiliar with any type of electrical equipment then stop and contact your line manager for advice on what to do next. Never become complacent in what you are doing;

- > If things have gone wrong then stop and immediately contact the Control Centre - Do not try to remedy the problem until the correct safety systems have been followed;

- > Be aware of the hours you and your colleagues are working - Fatigue creeps up and can cause you to work differently to normal. Working excessive hours can also cause health issues which can affect all aspects of your life;
- > Location and labelling of shutters and safety locks - On a withdrawable circuit breaker pay particular attention to the relevant sections of the Distribution Safety Rules.

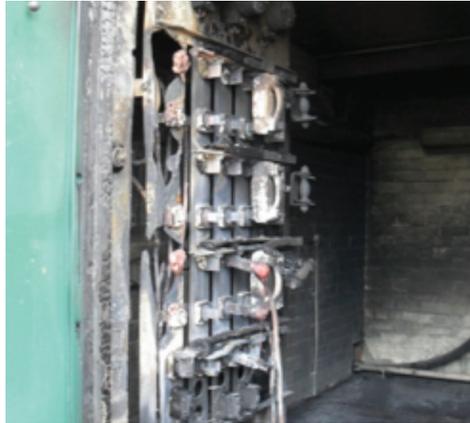
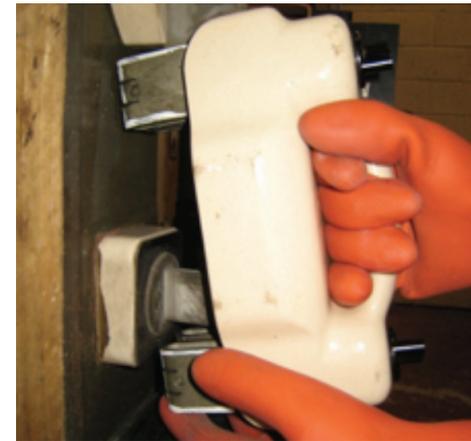
FAILURE OF THE LV BOARD AT A SUBSTATION (2016)

Subsequent investigation revealed that the LV board at the substation had disruptively failed whilst the operative was carrying out an operation to remove fuses on the LV board to isolate a faulty circuit for the jointer to commence work.

A specialist electrical consultancy was employed to carry out a forensic examination of the LV board, which was a Lucy open type board, in order to determine the cause of the initial flashover and to explain how the short circuit could have occurred. It was established that there was a split second drop of the fuse carrier caused by a combination of weight of the porcelain fuse and release of contact tension as the fuse was withdrawn. The operator was unaware and unable to react before a phase to earth contact was made.

An incident occurred when an operative was injured following a disruptive failure of the LV board at a substation. The operative was carrying out the isolation of an LV main to enable an LV cable to be safely excavated to carry out a fault repair. The operative had no burn injuries from the incident but was kept in hospital overnight due to smoke inhalation. He was wearing full PPE which prevented further injuries.

The spring contact on this type of fuse carrier is designed to grip the wedge on the board independently. The toggle on the front on the fuse carrier can then be tightened to increase the grip on the contacts. The investigation into the incident found that over time the spring contact can lose its tension and then relies on the toggle to hold it in place.

Following the incident a ban on operating on these type boards was instigated pending an interim solution; this involved the placement of an insulating block under the bottom contact of each fuse to prevent the fuses from falling far enough to cause a short circuit to the steelwork of the LV

board. The permanent solution consisted of removal and replacement of all of this type of LV board.

- > Following this incident a decision was taken to replace this particular type of LV board;
- > In addition, following a further incident in another DNO, the following restrictions on this type of board were introduced:

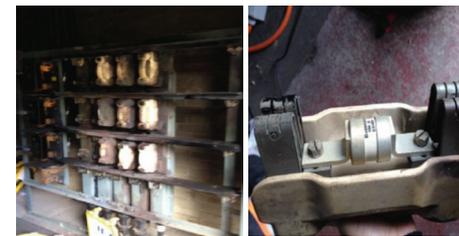
FLASHOVER ON SPRING CONTACT TYPE LV BOARD (2015)

A flashover occurred during the removal of a fuse on an open LV board. The fuses on the board were spring contact fuses with tightening lugs. The incident occurred as the toggles on the fuse carrier were being loosened so it could be removed. At this point the fuse carrier dropped making contact between the metal back box of the LV board and a live busbar.

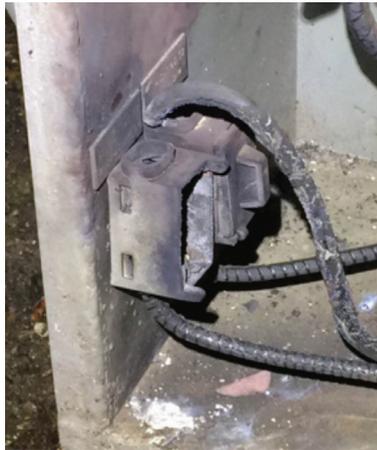
A jointer was investigating a report of flickering street lights and, whilst withdrawing an LV fuse controlling the street lights which was installed within a LV pillar, he sustained burns to his hand when a flashover occurred.

A jointer checking supplies in an LV distribution board decided to remove a street light cut-out fuse from its holder as there had been reports of street lights flickering in the area.

Appropriate PPE for the task was being worn but, when attempts to remove the fuse failed due to struggling to get a good grip on the fuse, he decided to remove his

- > Never be tempted to remove any PPE for ease of completing a task;
- > Staff to be vigilant as the task progresses and ensure that they are wearing the correct PPE for the task in compliance with company procedures;
- > A continual assessment of the risks associated with the task being carried out is required, and the relevant control measures to minimise the risk of injury determined;
- > All operational staff were briefed and a SHE Bulletin issued.

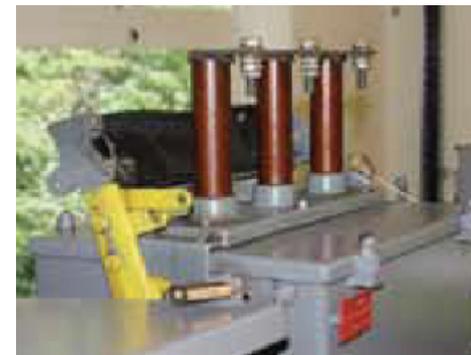
These incidents can be very severe because the insulating oil can be ignited by any flashover, leading to a fireball. These prods are designed to be used safely in tanks which may have live conductors in them. They rely on a correct fit to guide them, so correct use of the right prods and in good condition is critical.

Two engineers were killed and a fitter was seriously injured at a substation when a metal guide rod became detached from a set of test prods on an oil filled ring main unit due to a loose nut, and fell onto the live HV metalwork at the bottom of the tank, causing a flashover and explosion which ignited the oil at a fault level of 180MVA.

In a separate incident an engineer used the wrong set of test prods to make test connections. As they were the wrong test prods they were not guided when they entered the tank, and they made contact with the live busbar bushing on the other side of the tank. This resulted in serious burns to the engineer.

- > All test prods must be subject to a robust system of inspection, identification, and labelling;
- > They must be kept in dry, safe and secure storage;
- > They must be protected from damage when transported, ideally in a box;
- > Test prods must have no removable parts;
- > Staff must have training in the use and care of test prods, including awareness of the hazards involved;
- > Test prods must be clearly identified and marked with the type of switchgear on which they are to be used; if there is any doubt then do not use them;
- > Never attempt to modify or dismantle test prods during use;
- > Consider testing from a location that does not involve test prods;
- > Inspect test plugs every time before use; never use test plugs that are in a poor condition or with any parts that are loose.

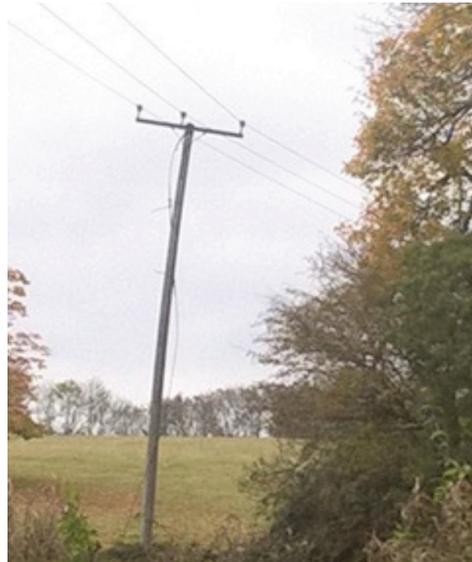
A combine harvester made contact with a low (4.85m) live 11kv overhead line (OHL). The OHL conductors were found to be low due to a damaged stay wire. The subsequent investigation revealed there had been opportunities to rectify the low line before the incident occurred, but the company had failed to act in time to prevent the incident.

The immediate impact was damage to the combine harvester and the OHL. Fortunately, nobody was hurt in this incident but there was a real potential for injury, or even a fatality.

In terms of the original incident, the line had been inspected in February 2015. The inspector noted the low line, but did not correctly raise a defect either for the low line or the damaged stay wire in the system. This meant that the defect was never progressed for repair.

In addition there was anecdotal evidence to suggest that local field staff were aware for some time of the damaged stay wire and resultant low conductors at this particular site, but nothing could be substantiated through a review of the company reporting system and other records.

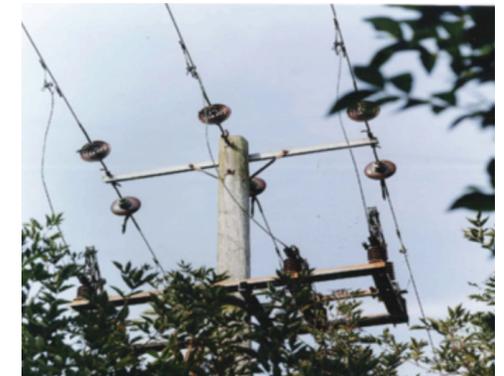
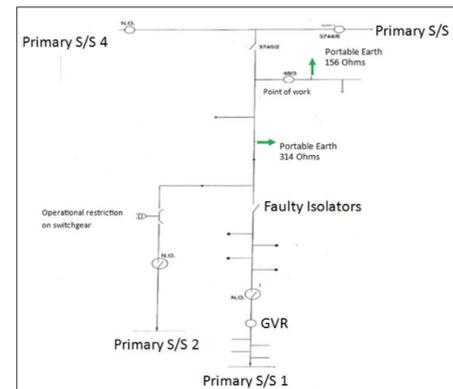
It was discovered that the centre phase of the isolators used as a point of isolation had not in fact opened, and this resulted in the centre phase voltage being applied to all three phases of the section of network being worked on when the auto-recloser was closed.

Previously the engineer had confirmed to the control engineer that the isolators had opened but he had clearly not carried out a thorough check. There was a significant amount of vegetation around the isolators which hindered the engineer's view.

Aside from the clear operational failures, failure to isolate and earth in accordance with the safety rules and failure to check correct operation of switchgear, there were issues around the management of the assets, namely:

- > Maintenance of isolators;
- > Vegetation management around network assets;
- > Management of switchgear defects.

Following this incident the practice of local control was withdrawn, the process for the management of switchgear subject to operational restrictions reviewed, and the policy on vegetation management reviewed.

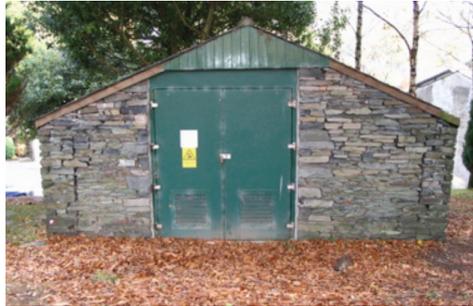
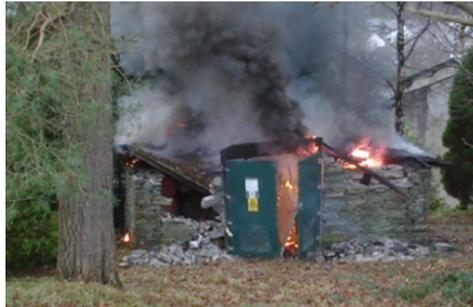
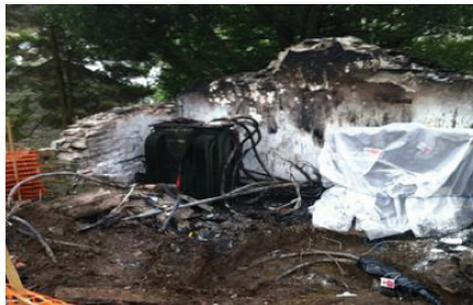
DISRUPTIVE FAILURE OF A FUSE-SWITCH (2013)

Following routine maintenance of a fuse-switch, the 11kV plant, associated transformer and low voltage switchboard suffered a disruptive failure. The failure occurred approximately 30 seconds after the unit was remotely re energised. The explosion demolished the entire substation and all assets within the building.

The investigation into the incident identified the most likely cause of the switchboard failure was due to contact pitting, incorrect contact alignment between the fixed and moving contacts on the switch fuse, and the rising busbar being out of its correct vertical plain leading to local overheating and thermal runaway. The previous plant maintenance policy did not require checking of the contact alignment.

- > A Dangerous Incident Notification (DIN) and Suspension of Operational Practice (SOP) was issued via the Energy Networks Association (ENA) to all member companies notifying them of the Fuse Switch Failure;
- > The DIN was an instant benefit for scheme members to immediately review the incident and, if deemed appropriate, instigate an immediate prohibition of live operations;
- > An Operational Instruction (OI) was applied when operating the equipment as summarised below, outlining the procedure to adopt in such circumstances:

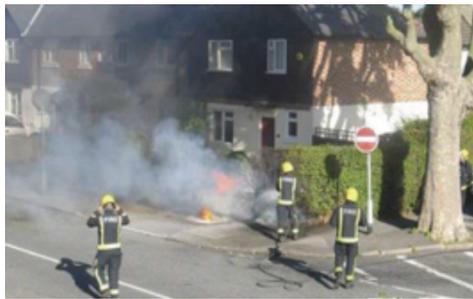
LINK BOX FAILURES

In the years from 2010 link box failures were increasing across the UK DNOs. Some of these failures were also disruptive and expelled energy into the street or surrounding of the asset. Disruptive events posed a risk to the public with DNO link boxes generally being installed in pavements.

One failure mechanism highlighted was the mechanical failure of the structure of a link box when the surrounding ground is backfilled and reinstated. The group revised the ENA specification for link disconnecting boxes to include specification details and a test regime to ensure that new boxes are resilient to the forces applied by installation.

- > As a result of the work of the group all DNOs will now use the new specification when their supply contracts are due for renewal;
- > DNOs have amended their inspection regimes and frequencies to take account of the SHE Position Paper;
- > Based on the limited volume of data available after these changes have been made, it appears that the measures have helped reduce the likelihood of disruptive failure and risk to the public.

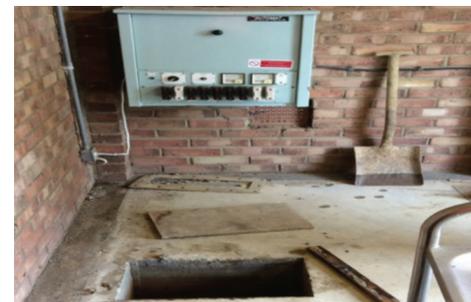
The craftsman noticed the wooden cover before he started the works on site. The cover itself looked dry and suitable to support his weight. The inspection commenced on site and, while moving his left foot onto the cover and applying his full weight, one of the wooden supports below the cover collapsed allowing the cover itself to fall. The craftsman's left leg fell into the hole grazing his left shin during the fall. Upon further examination the wooden support was found to be rotten.

- > The visual examination of the wooden cover as part of a dynamic risk assessment was not sufficient enough to indicate any structural issues with the cover;
- > Always fully assess any trench/manhole covers before standing on them; if found to be unsafe arrange to be replaced or barriered off immediately;
- > The timber supports and wooden cover were replaced;
- > Fitters and asset inspectors were reminded to inspect trench covers as part of substation inspection.

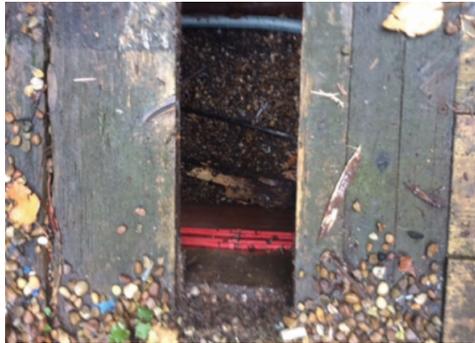
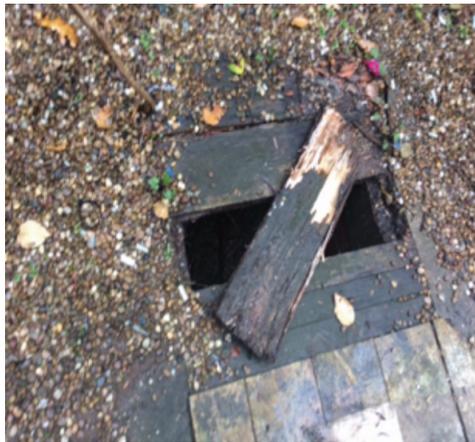
- > The fitter should have made a better assessment of the site and been aware that these wooden trench covers may not be as solid as they look;

- > Relevant staff were briefed on the need for greater care to be taken when entering customer's substations;
- > The customer was made aware of the incident and requested to fill in the trench and remove the wooden covers.
