**AUTUMN 2012 ENA
SHE MANAGERS
REVIEW OF PAST ASSET
RELATED INCIDENTS**

SHE REVIEW – AUTUMN 2012

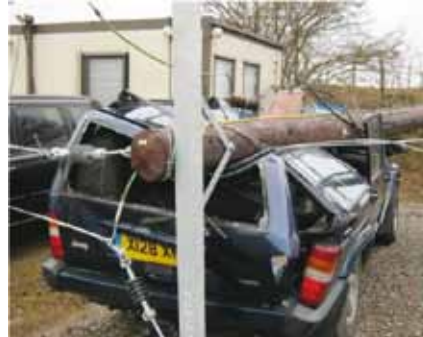
POLE FALLS INTO CAR PARK

In one incident an 11kV terminal pole with a pole transformer mounted on it fell into a car park damaging eight vehicles and writing one of them off.

The direct cause of the collapse was found to be that the pole had not been installed to the correct depth.

Underlying and contributory causes included:

- > Inadequate assessment of the site and soil conditions.
- > Failure to install to correct depth, and use a baulk.
- > Poor supervision, quality control and auditing of the installation process.

- > It is important that anyone involved in the erection of poles is competent to assess site conditions and understands the importance of good installation.
- > Always install poles to the correct depth.
- > Robust supervision and quality control of the process is needed.

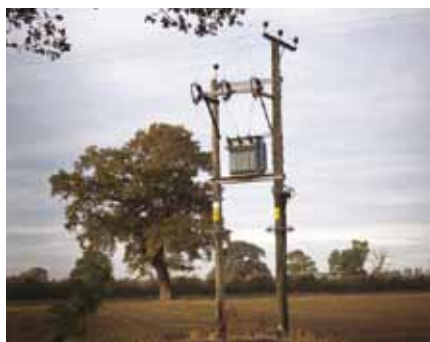
POLE FALLS PARTIALLY AS CONDUCTORS AND PLANT ARE TAKEN DOWN

In another incident a team was dismantling an OHL on sloping ground and removed the conductors on the uphill side of a pole mounted transformer. As the transformer was being removed from the pole, the pole started to fall down the slope until it was restrained by the stay wire which caught in a tree. Two linesmen were attached to the pole and one was slightly injured.

On investigation it was found that there was a void in the ground around the base of the pole, which was not visible prior to the work.

- > The pole was not firmly secured in the ground, either due to poor installation or subsequent erosion.
- > The on-site risk assessment and subsequent method adopted did not identify this possible risk.

- > If possible, complete other work on a pole before removing conductors.
- > Inspect poles carefully before climbing them.
- > If necessary, provide temporary support for the pole.
- > Always ensure poles are installed correctly, and that backfill is properly consolidated and rammed.

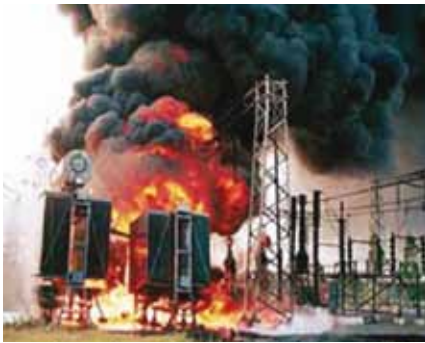
A fatal incident occurred when an engineer tried to manually operate a high voltage tap changer and the unit exploded, killing the engineer.

The direct cause of the incident was the failure of the mechanism in the tap changer leading to an electrical fault which caused the oil in the unit to ignite and explode.

- > A failure to carry out a modification to the tap changer which had been recommended some years before.
- > The failure to understand the significance of repeated tap changer alarms and malfunctions.

- > Alarms and defects on plant should be dealt with by staff who are trained and experienced in the maintenance of that type of plant.
- > A robust asset management system is needed to ensure that recommended modifications are recorded, scheduled and carried out.
- > Repeated alarms should be interpreted as an indication that there may be a more serious underlying problem which needs to be investigated.

- > Manual live operation of tap changers should be reviewed and risk assessed, with appropriate controls applied.
- > Where evidence exists that the internal mechanisms of either the diverter or selector are damaged, the unit should not be operated live.
- > Ensure that staff dealing with alarms and defects on equipment have the knowledge, skills and competency to deal with that equipment.

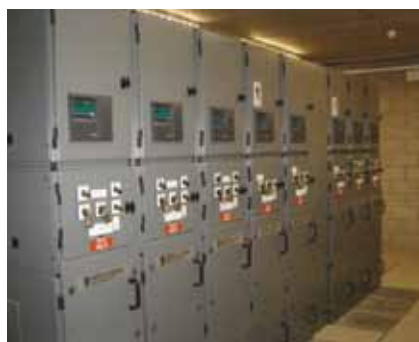
In a similar incident involving 33kV switchgear, a test lead was left on cable terminations and subsequently the covers were replaced with the test lead still connected, resulting in an explosion and extensive damage when the circuit was re-energised. No one was injured in this case.

- > The engineer made contact with live test plugs which were left inserted in the busbar spouts at the time they were re-energised.
- > The test lead was left inside the gear.

- > Failure to remove the test prods and test leads.
- > Failure to check and confirm that the test plugs and test leads had been removed before the Sanctions for Test were cancelled.

- > Wherever possible, re-energise from the point at which testing was done, and don't remove panels to enable testing unless there is no other option.
- > Always check that test plugs, tools and any other items have been removed from busbar and circuit spouts that were under test and that the spouts have been locked shut before the Sanction for Test is cancelled.
- > It is important to remain focussed throughout all switching and HV testing activities. Avoid distractions, exclude those not involved, and use a checklist if necessary to help correct restoration.
- > Never touch or try to remove test plugs or connections from busbar or circuit spouts if the circuit concerned is not subject to a safety document which allows you to do so.

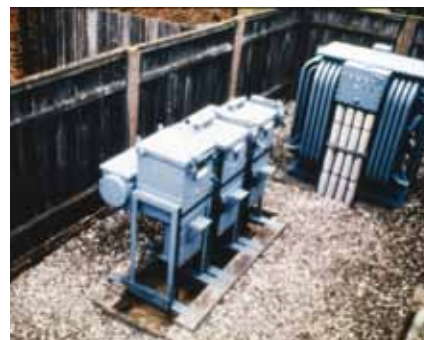
Two small boys trespassed into a substation and were killed when 11kV switchgear faulted while they were playing in the substation.

The fault occurred on a busbar joint chamber which joined the busbars of two items of switchgear in the substation.

The investigation concluded that the equipment had probably been damaged by a previous event which had left the cover fractured, allowing the ingress of moisture.

- > Reporting damage to equipment before it faults can save lives.
- > Once defects or damage are reported, they must be appropriately prioritised and rectified in a reasonable timescale.
- > Always check for and report any signs of damage, trespass and vandalism.
- > If a predominantly underground circuit trips but no fault is found, give consideration to further inspection of sites on the circuit.
- > Use the ENA booklet on substation security or your company's own guidance on substation security.

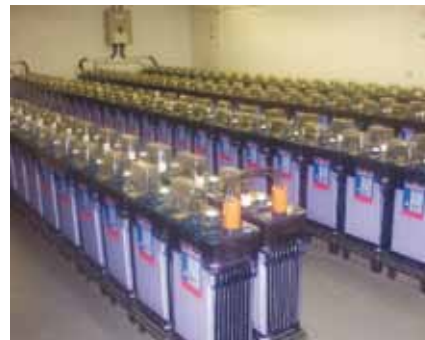
COMPLETE BATTERY STOLEN

All the cells from a number of primary substation batteries were stolen, but this was not noticed immediately because the battery charger was connected across the battery terminals.

- > We all need to be vigilant for signs of intrusion and theft.
- > Effective control of access to substations and keys must be ensured.
- > The design and maintenance processes should ensure that the routine inspection and testing of batteries reliably indicates cell and battery condition.
- > A robust regime of battery testing and monitoring should be implemented.

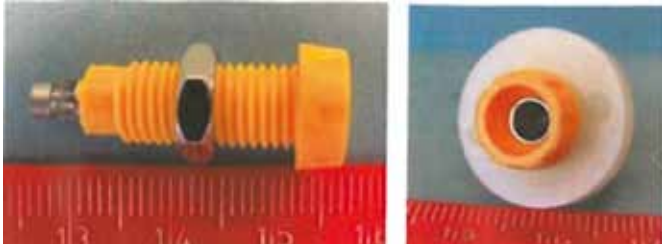
An engineer was using un-fused test leads to measure voltage by plugging into the 4mm un-fused test sockets on an LV Board.

A flashover occurred and the engineer received burns to his hands. It is believed that the insulated body of the test socket failed and the conducting part of the broken socket made contact with the earthed metal of the LV Board.

Similar failures had occurred previously and in other companies. A modification had been recommended to prevent the problem.

Other incidents had also involved test leads with terminations that were not 4mm plugs being forced into the sockets.

- > Poor design.
- > Use of wrong plugs.
- > Lack of care when using sockets.

- > Always use test leads with fuses when taking measurements on live equipment.
- > Known defects should be effectively followed up promptly to avoid similar incidents on the same type of equipment or plant.
- > Consider reporting any defects to the ENA NEDERs scheme through your company contact.
- > Consider banning the use of components that have a generic fault which can lead to dangerous incidents.
