**2017 SHE REVIEW
OF PAST INCIDENTS
ASSET MANAGEMENT**

POWERING IMPROVEMENT 2015 – 2020

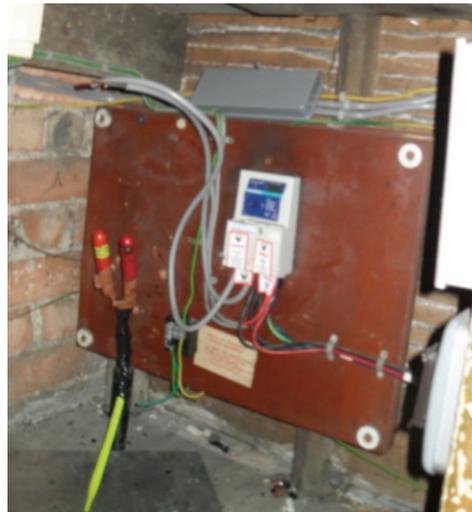
Not related to the incident the cut-out was a metal clad-cut-out, but this had no bearing on the incident. The cut-out had already been removed when the incident happened. However, following the incident the HSE made it clear that they did not approve of any work on metal clad cut-outs so the practice was banned in the company.
