**ASSET MANAGEMENT  
AND MAINTENANCE  
REVIEW OF PAST  
INCIDENTS**

## ASSET MANAGEMENT AND MAINTENANCE

# INTRODUCTION

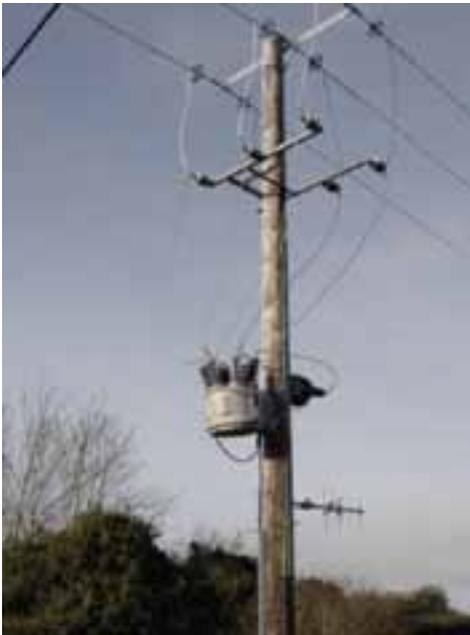
# POLE FALLS INTO CAR PARK

In one incident an 11kV terminal pole with a pole transformer mounted on it fell into a car park damaging eight vehicles and writing one of them off.

The direct cause of the collapse was found to be that the pole had not been installed to the correct depth.

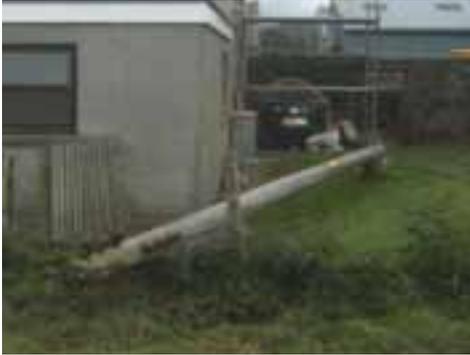
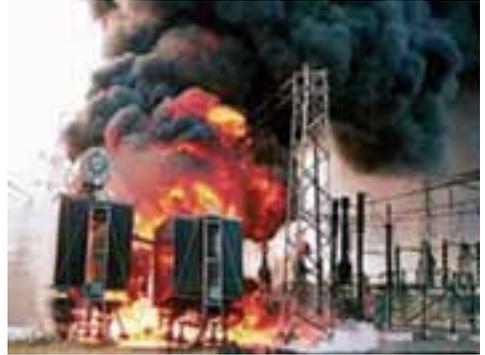
## DECAYED POLES

There have been a number of incidents where linesmen have climbed decayed poles which have then fallen while the linesmen were on the pole. Some of these have resulted in serious injuries or fatalities, both to linesmen on the poles and to others who have been hit by the falling poles.

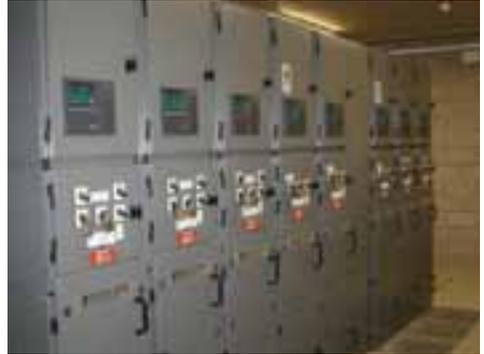
## 33KV INCIDENT

In a similar incident involving 33kV switchgear, a test lead was left on cable terminations and subsequently the covers were replaced with the test lead still connected, resulting in an explosion and extensive damage when the circuit was re-energised. No one was injured in this case.

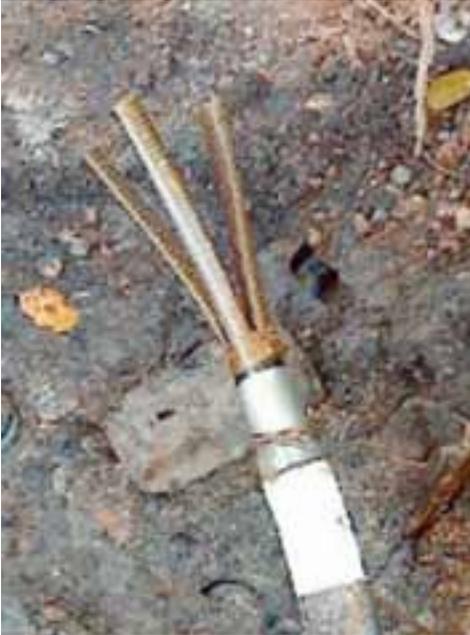
## ENGINEER KILLED AFTER TOUCHING HV CABLE WITH SEVERE DAMAGE

In one incident an HV cable was severely damaged by a mechanical excavator, leaving the cable with a severed end pointing upwards with the cores splayed apart. Two engineers attended the site and because the damage to the cable was so severe, they assumed the cable must be dead. It was not. One of the engineers was fatally injured when he approached the damaged end.

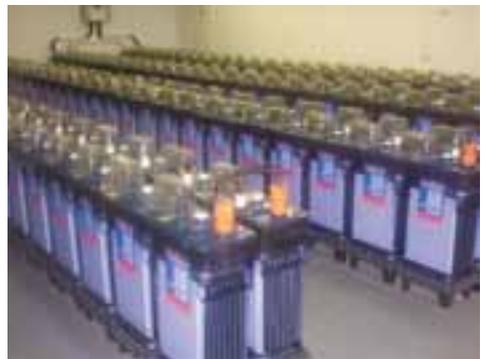
## COMPLETE BATTERY STOLEN

All the cells from a number of primary substation batteries were stolen, but this was not noticed immediately because the battery charger was connected across the battery terminals.
